EXECUTIVE SUMMARY

In 2022, the City of Prairie Village requested that Clark & Enersen provide assistance in developing an Existing Building Conditions Analysis of the existing structures at the 7700 Mission Road Municipal Complex to aid in the creation of a conceptual master plan for the campus. As part of this endeavor the Clark & Enersen "Review Team" studied each building system to determine its general condition and recommendations for updates.

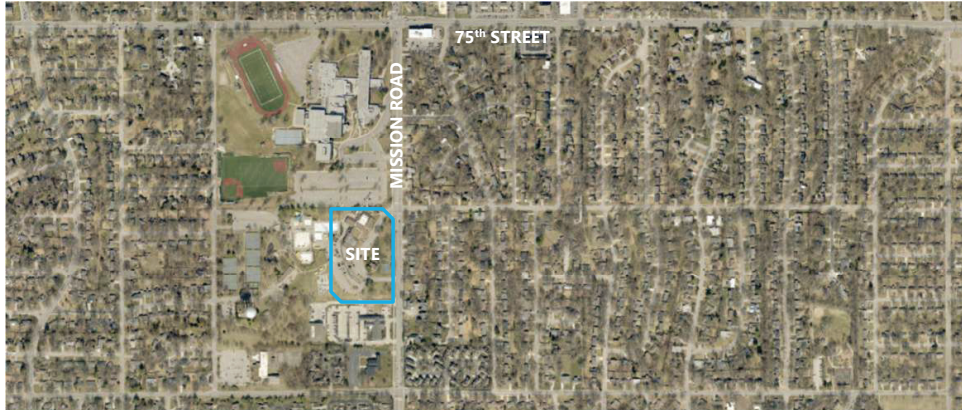
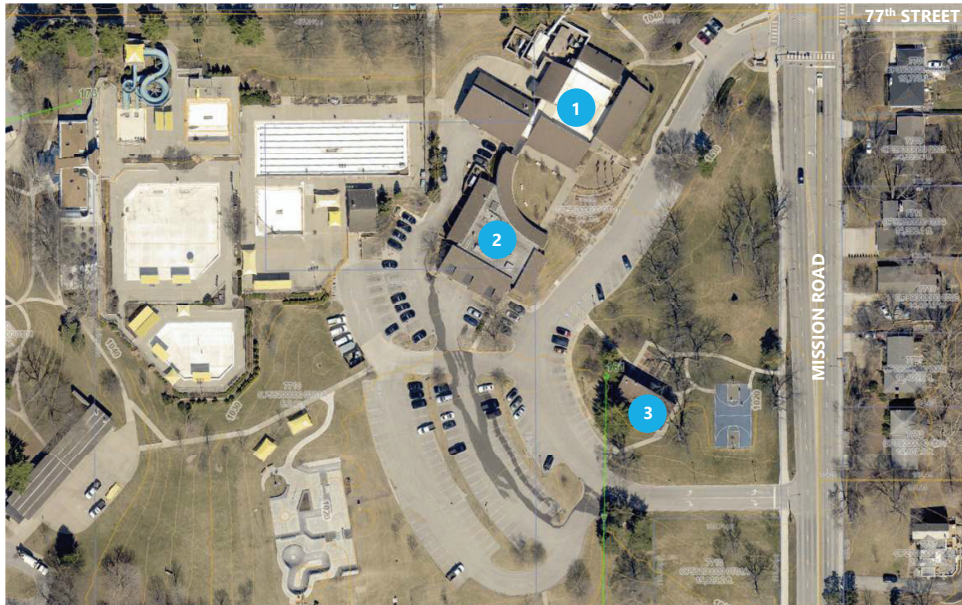
The images to the left provide an overview of the Prairie Village Municipal Complex and the different structures that are currently in place. The Prairie Village Municipal Complex is located just south of 77th Street along the west side of Mission Road.

The campus itself is comprised of 3 structures:

1. City Hall
2. Police Department
3. Community Center
